BOTTLED WATER COMPANY IMPLEMENTS LARGE-FORMAT IR WINDOWS

The company brought in consultants for recommendations on placement, sizing, and types of infrared windows to be installed at the Ontario, Canada facility. After an initial site survey, the consultants recommended the IRW-xPC series in various sizes to complete this project. The IRW-xPC series is a NEMA 4 / IP65 rated IR window and ideal for indoor applications. Available sizes are 6, 12, and 24 inches.

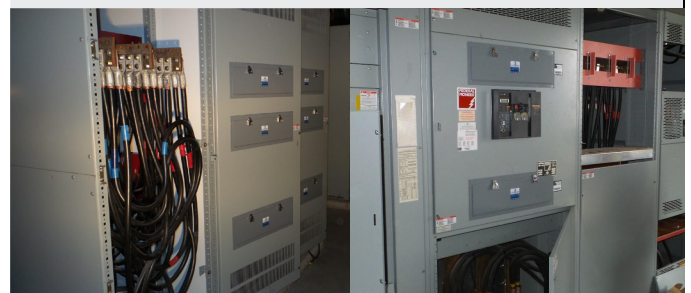
Incoming line connection and main breaker cabinets were also fitted with 24-inch windows
